Indyme Precisely Identifies Circuit Board Defects Using Corelis Boundary-Scan Advanced Diagnostics

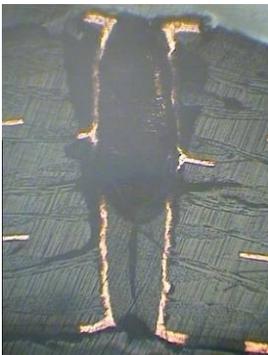
Hole with poor copper plating

Once installed, ScanExpress ADO was able to quickly and accurately identify the fault down to the pin and net level, leading debug efforts by the manufacturer straight toward one particular Plated Through-Hole (PTH) in the PCA. Cross sectional photos of the PTH were taken, revealing poor copper plating due to excess drilling residue. With the source of the problem now identified, action was taken to update the manufacturing process, ultimately resulting in improved yields. "Corelis boundary-scan with ScanExpress ADO really saved the day by identifying these early stage production problems. It quickly identified the issue so that we could take corrective action," claimed Bob.
